Barangaroo
29 Hickson Road
Sydney NSW 2000

Incident date
Wednesday, 12 Mar 2014

FIRE INVESTIGATION SYNOPSIS

Fire Investigation & Research Unit
Community Safety Directorate

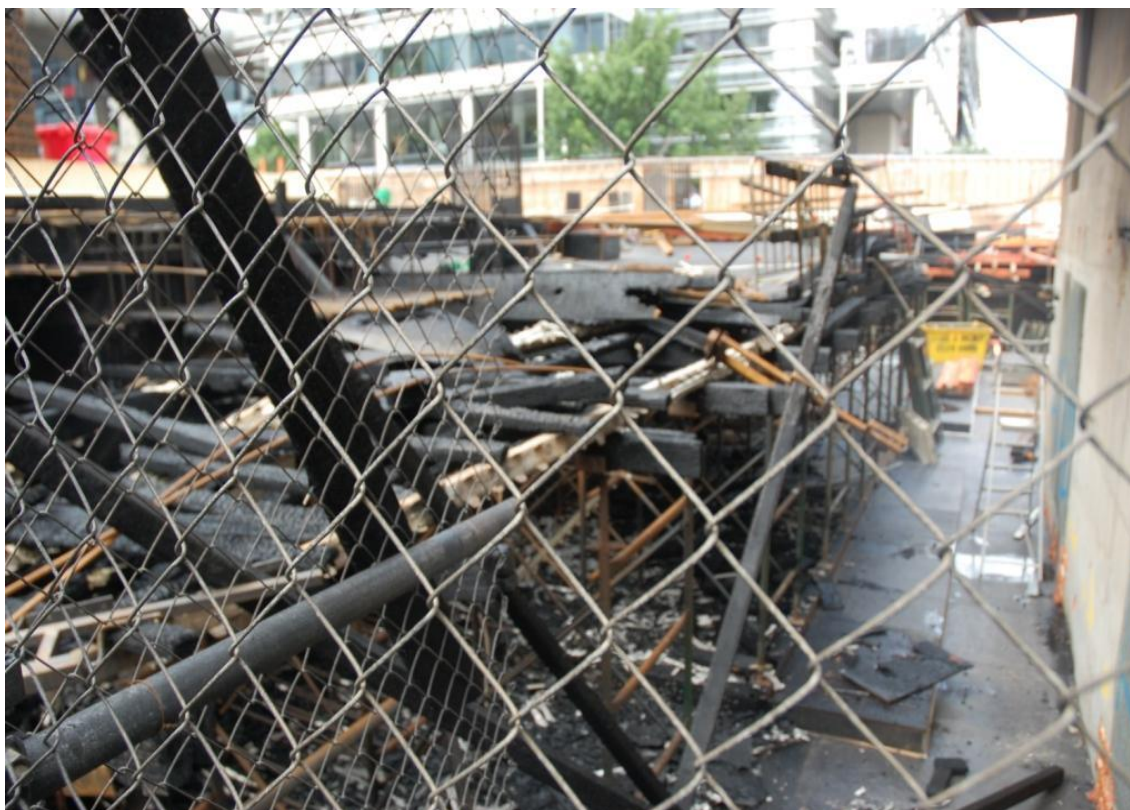
Basement level one showed severe fire damage to timber formwork throughout the area which was visible from ground level.
The main fire area was badly damaged and inaccessible.

Photo 84 showing fire damage to formwork at ground level. Area inaccessible.

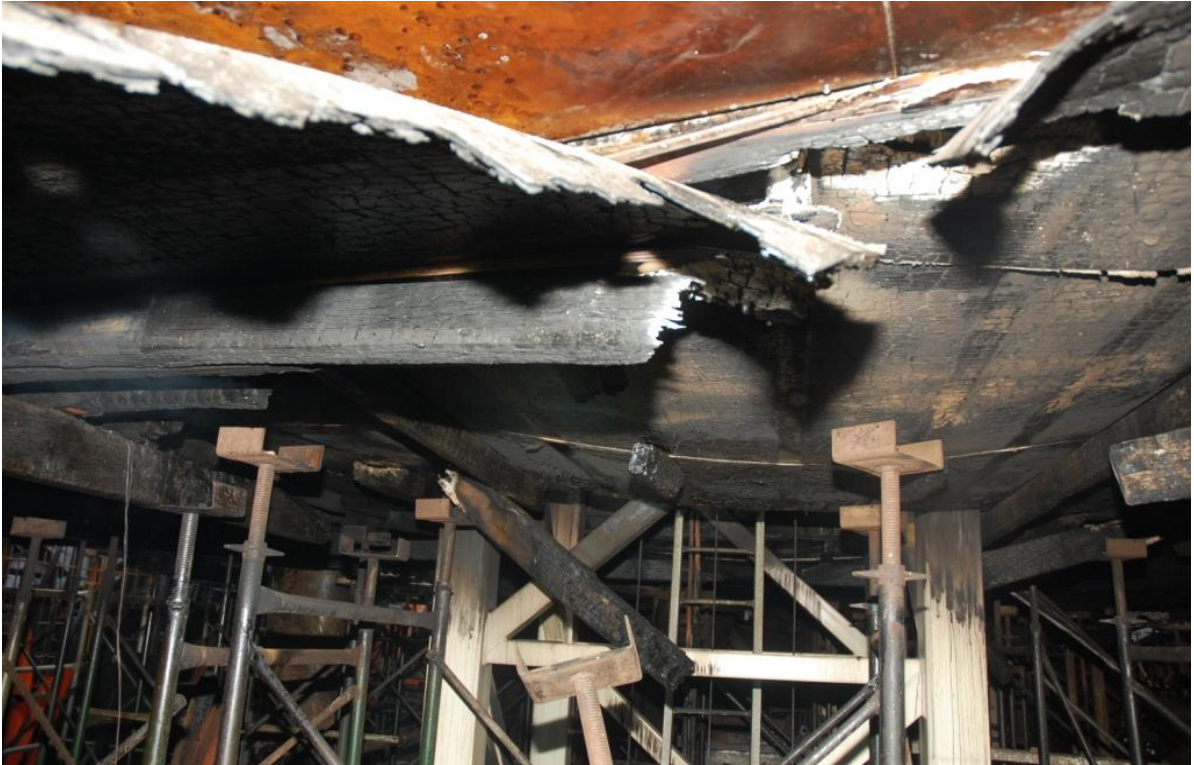
The formwork on Basement level one was mostly burnt through at ceiling level and partially destroyed at ground level with the remaining timber showing deep charring.

Photo 22 showing Basement level one: Damage at ceiling height.

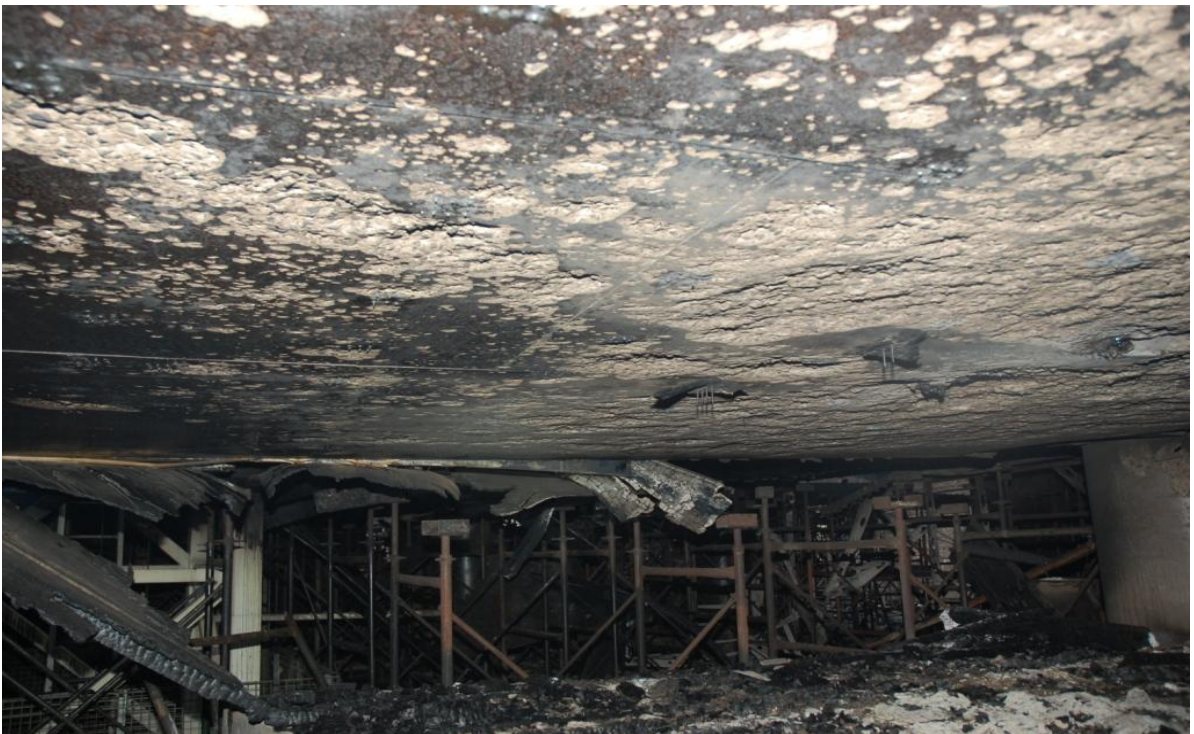
Basement level one showed large areas of exposed concrete with soot deposits and displaying chipping and pitting damage from spalling¹.

Photo 16 showing Basement level one: Soot deposits to concrete and spalling.

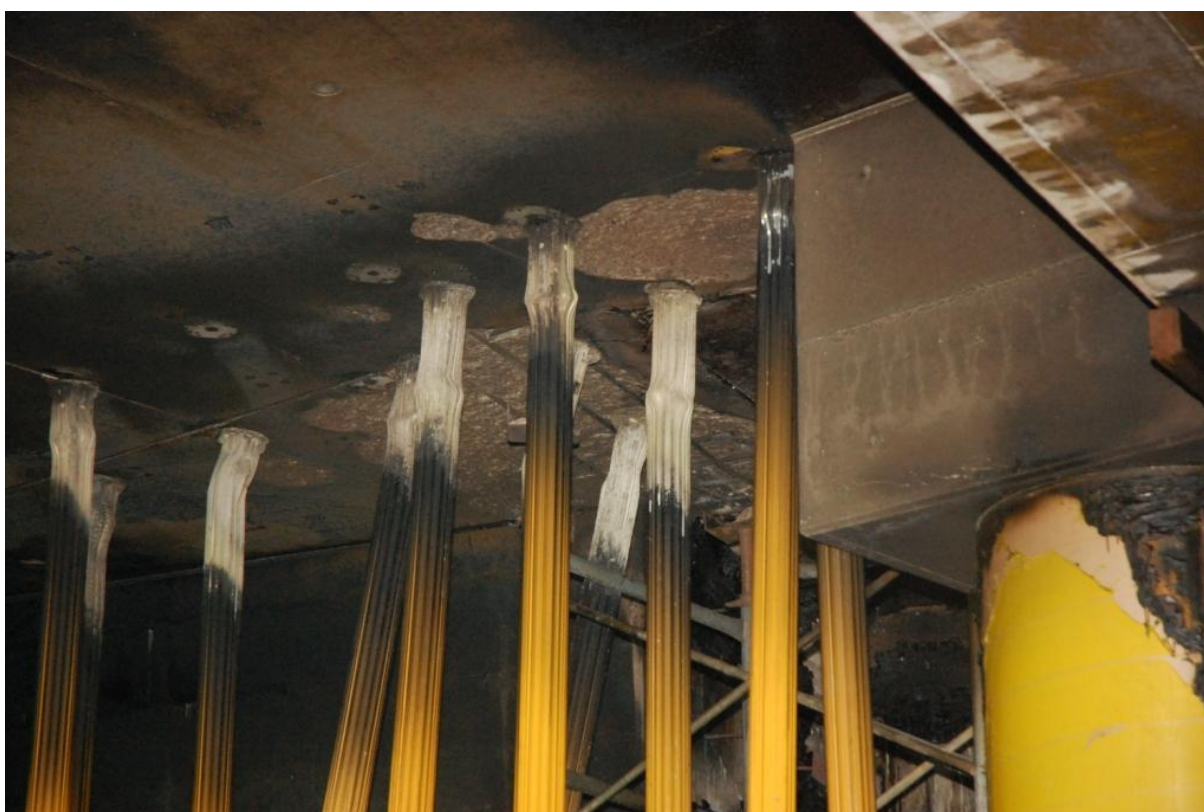
The aluminium reinforcement props on the outer limits of the area involved in fire on basement level one showed signs of being exposed to extreme heat. The concrete above the supporting props showed a dark brown deposit of soot. The timber formwork in this area showed signs of deep char. The upper ends of the aluminium supports were deformed and melted indicating that the material was exposed to temperatures of around 660°C¹. At the outer limits of the fire damage area were aluminium support props which showed signs of clean burn² which occurs when soot has failed to deposit because of high surface temperatures. The visible fire damage to the aluminium support props indicates that hot fire gases were burning in conjunction with the combustible materials and producing temperatures in excess of 600°C

Photo 45 showing basement level one aluminium support props.

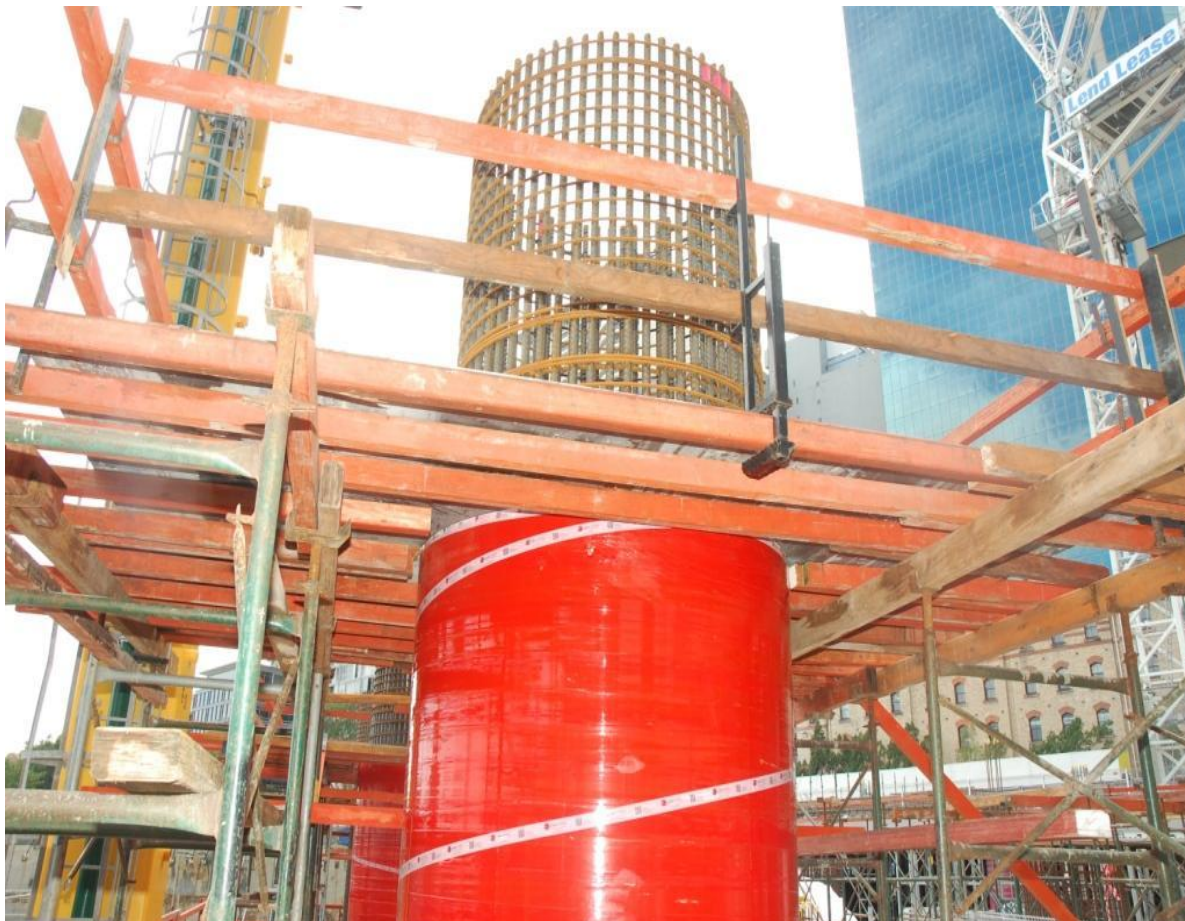
The polystyrene product formwork surrounding the steel reinforcement at this column was completely destroyed.

Photo 73 showing an example of the polystyrene product used to form the concrete columns. This picture is taken from a separate area of the Barangaroo site. It is confirmed by Lend Lease staff as being the same as the product used in the fire involved area.

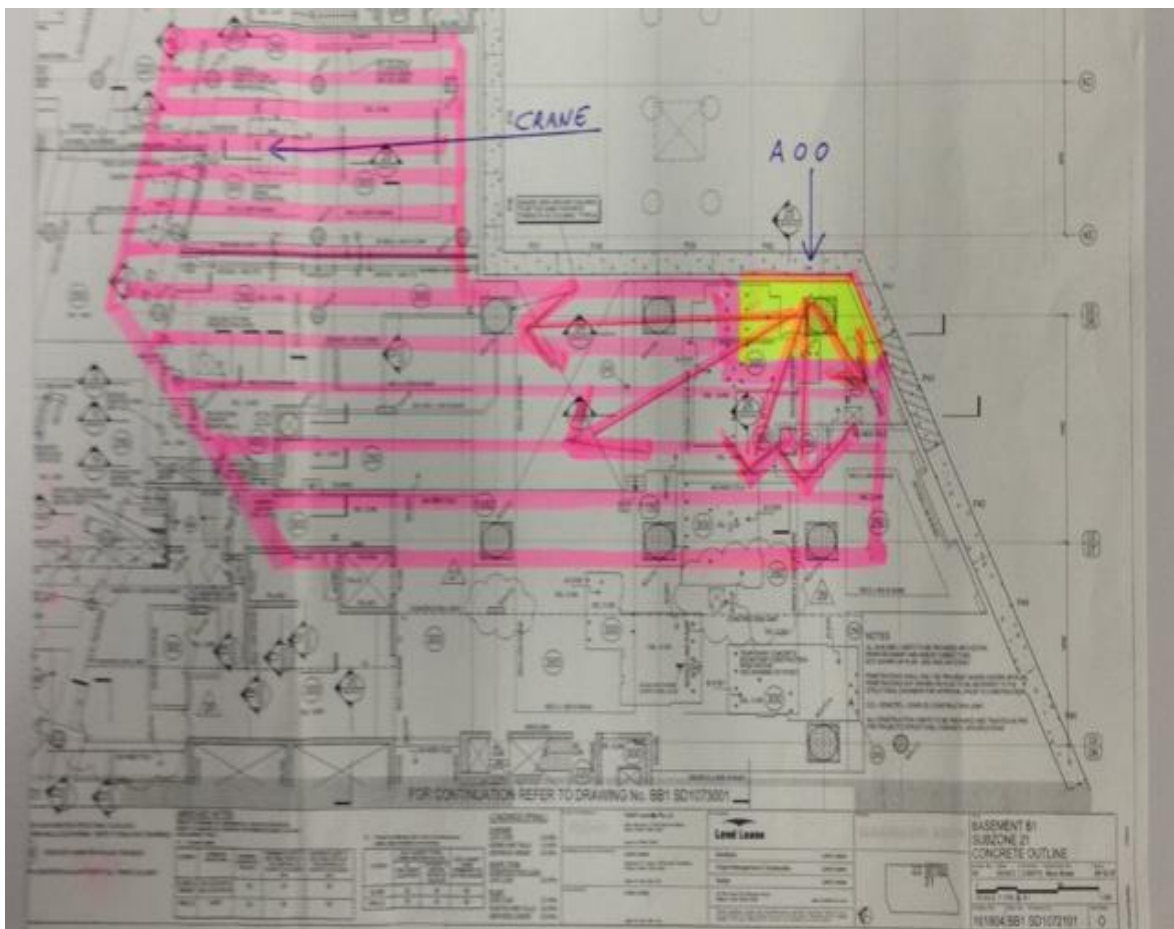
The area of origin appears to be at the Southern most end of the site perimeter. This area was being prepared for concrete pour. The area of most damage appears to be the first basement level.

The destruction of the combined formwork where the concrete column base extends to the first basement level indicates the area of most damage to be the southernmost column beginning at the first basement level floor. This is my observation from approximately six metres away. The area was inaccessible at the time of investigation and no excavation had been carried out to allow further investigation.

Photo of building plan basement one showing fire involved area and area of origin.

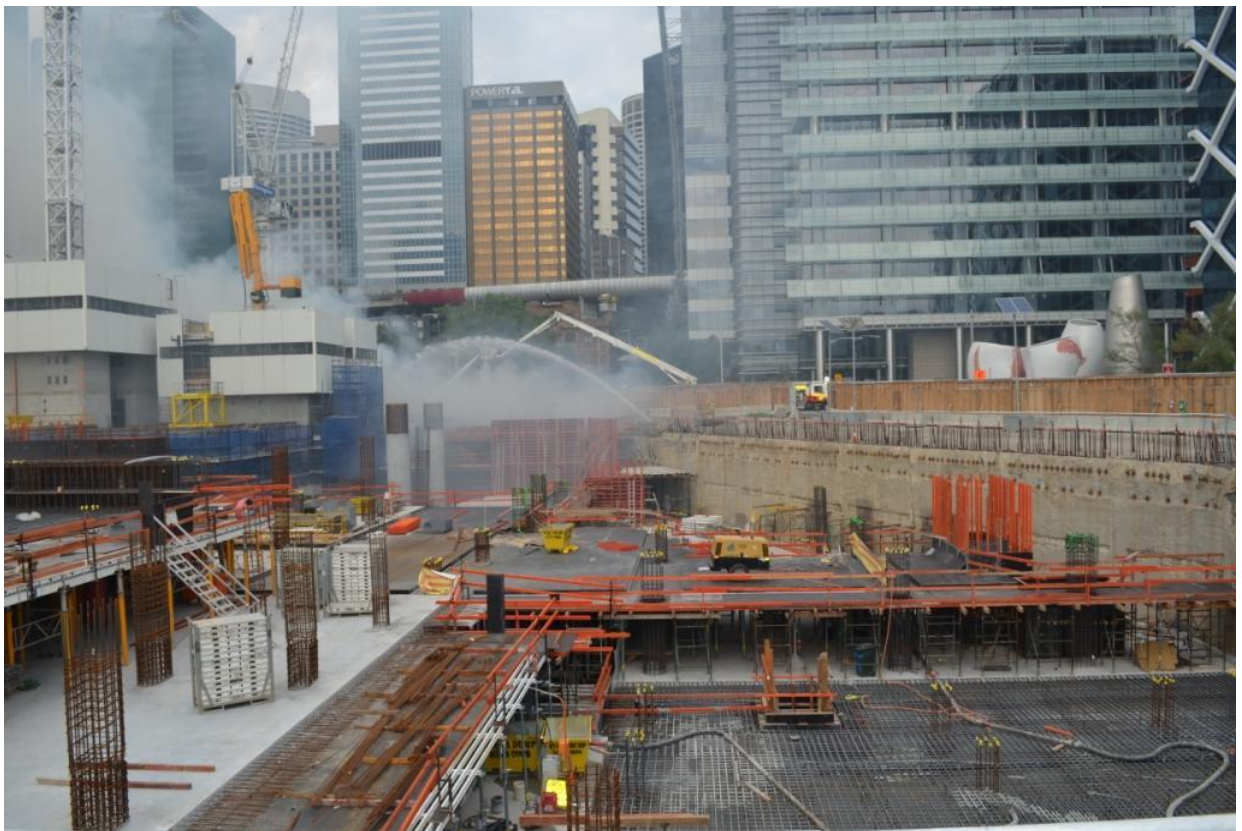
Photo 21 showing the placement and layout of formwork at a separate area of the Barangaroo site. Firefighting operations visible in background.
