Fire research report

Research Tests: Hoarding Fire Behaviour

This fire research report provides an analysis of hoarding fire behaviour from two test burns conducted at the CSIRO fire research laboratory in July 2014

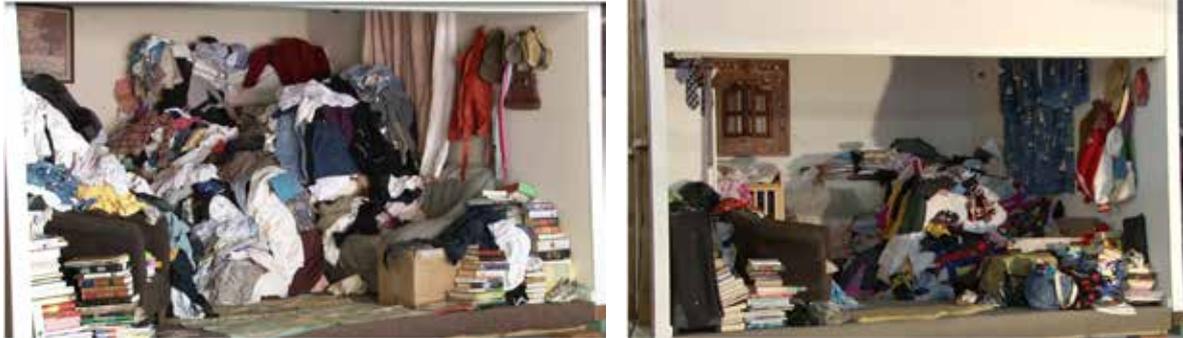
Figure 1: CIR level 8 (left) and level 5 (right) as used in test 1 and 2 respectively

Two full-scale scenario recreation burns of a bedroom were conducted for this analysis, test 1 being CIR level 8 (severe) and test 2 being CIR level 5 (moderate).

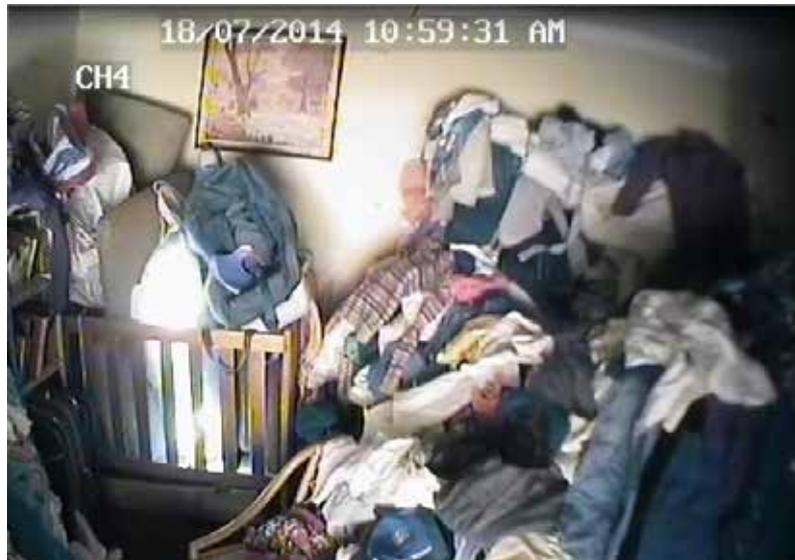
- (a) For test 1, a piece of paper was scrunched and ignited by a lighter which was placed at the bottom of materials piled into the cot.

Figure 4: Ignition from lit paper placed at the bottom of material pile in cot (Test 1)

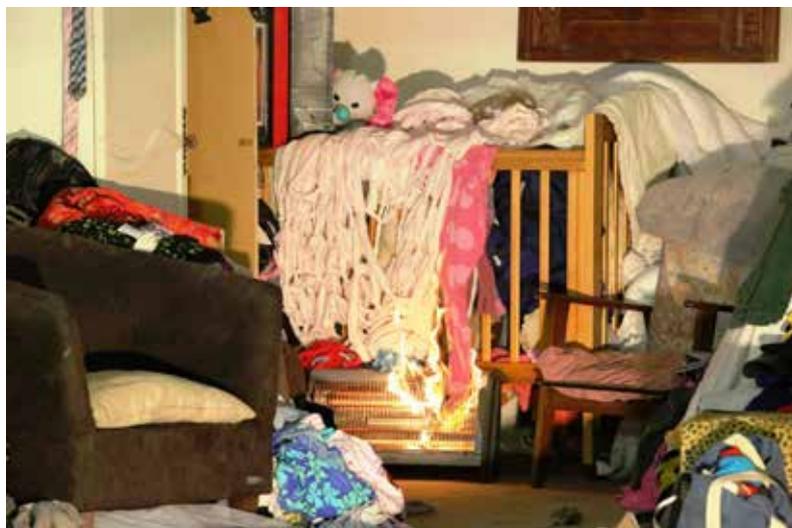
- (b) For test 2, clothing was draped over the side of the cot and placed in contact with a standard electric radiant bar heater, which was switched ON to commence the test.

Figure 5: Ignition from radiant bar heater showing first material ignited (Test 2)

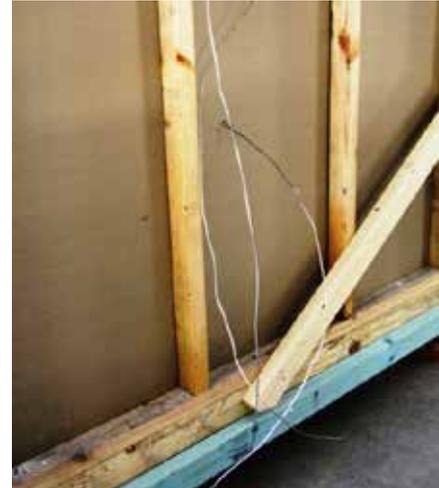
Figure 7: Thermocouple installation

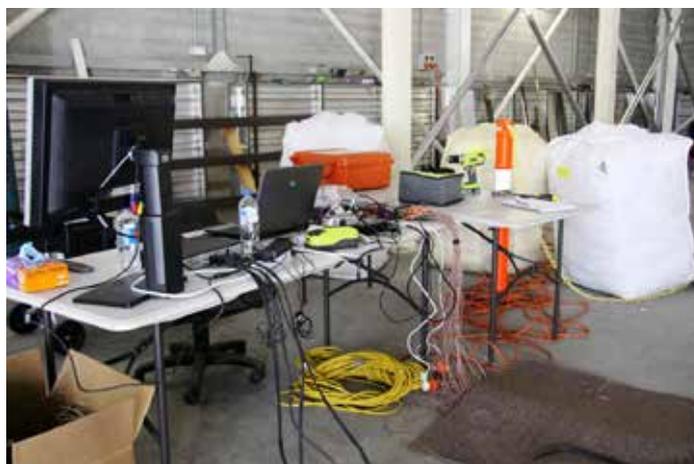
Figure 7: Set up of equipment monitoring station

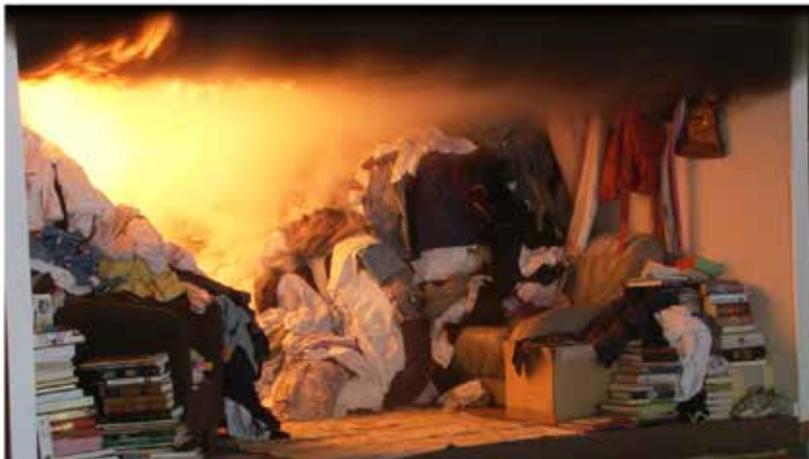
The polyurethane cushions quickly ignited allowing fire to rapidly spread vertically and laterally through the combustibles within the cot. A dense smoke layer formed very quickly from the combusting foam cushions with the ceiling mounted smoke alarm activating only 35 seconds after ignition.

Figure 8: Early fire growth and rapid fire spread (Test 1)

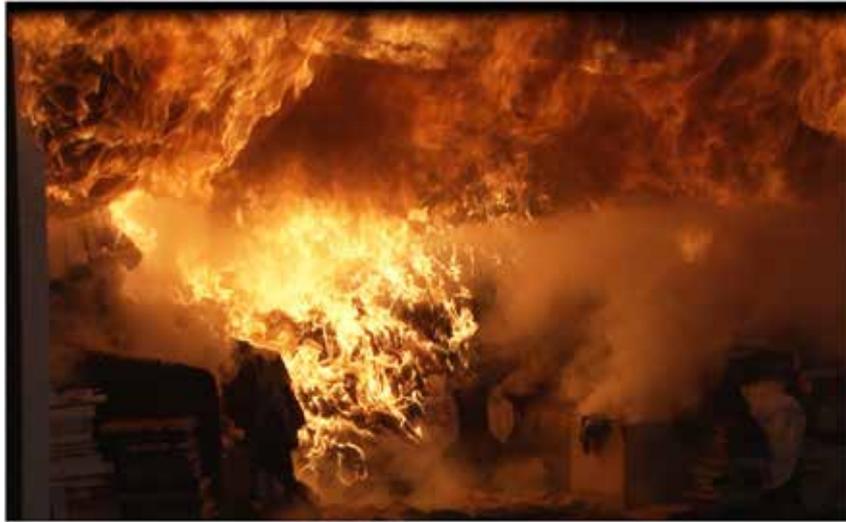
Flashover was reached in approximately 100 seconds, where ceiling gas temperatures were around 800°C.

Figure 9: Fire at flashover stage – flashover was reached in 100 seconds (Test 1)

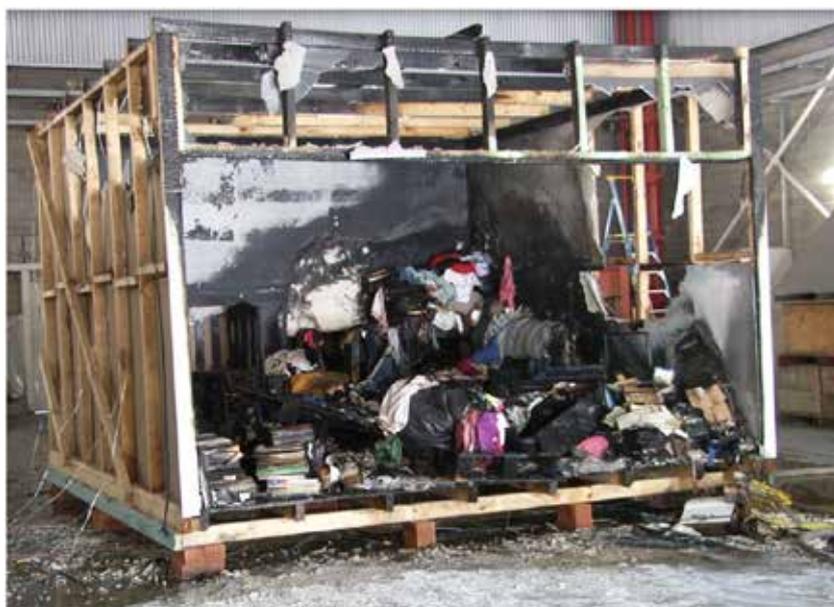
Extinguishment saw immediate cooling of all gas temperatures. A significant degree of overhaul was required by firefighters to extinguish all pockets for fire amongst the hoarded materials, and a Thermal Imaging Camera was required to locate these 'hot spots' during extinguishment.

Figure 11: Post fire damage and debris (Test 1)

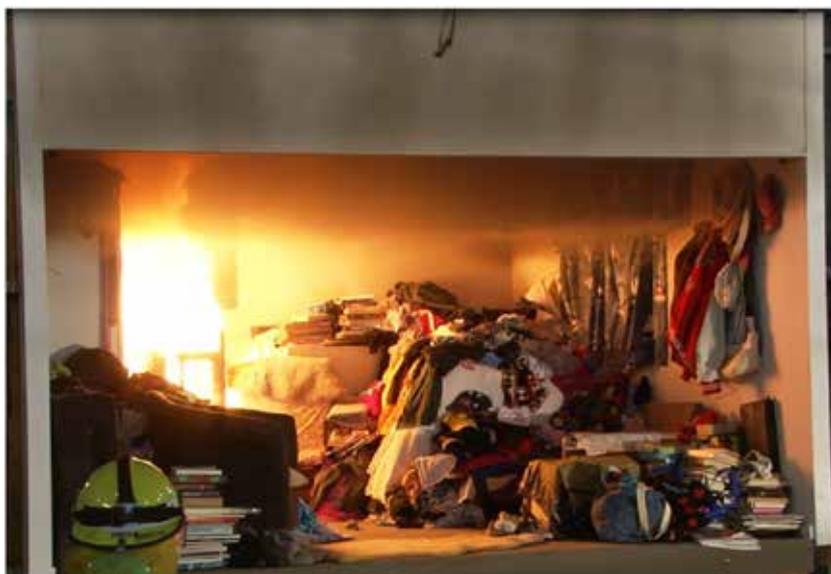
Ignition commenced at 10:54hrs by connecting power to switch ON the electric radiant bar heater. After a few seconds the flannelette pyjamas in contact with the heater ignited and power to the heater was disconnected. Initial fire growth was limited by the flammability and spread of flame index of the pyjamas. Fire spread up the clothing was quick, however lateral fire spread to fuels within the cot was quite slow, especially compared to test 1.

Figure 12: Early fire growth and fire spread (Test 2)

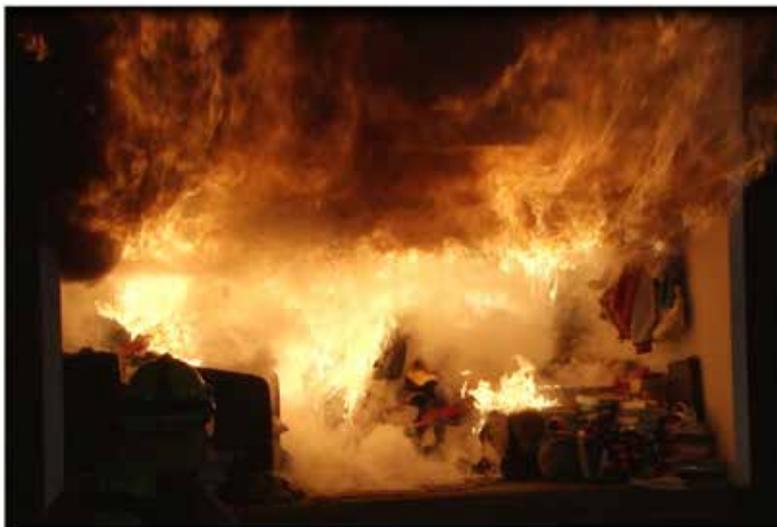
When flashover occurred, gas temperature at the ceiling was 977.8°C and temperature at the floor was 692.6°C. Temperatures were steadily increasing post flashover, however the test was terminated within 30 seconds of reaching flashover due to a minor explosion which resulted in a projectile causing concern for safety.

Note: The cause of this explosion is unknown however it is strongly suspected that it was a battery, possibly from the ceiling mounted smoke alarm.

Figure 13: Fire at flashover stage – flashover was reached in 260 seconds (Test 2)

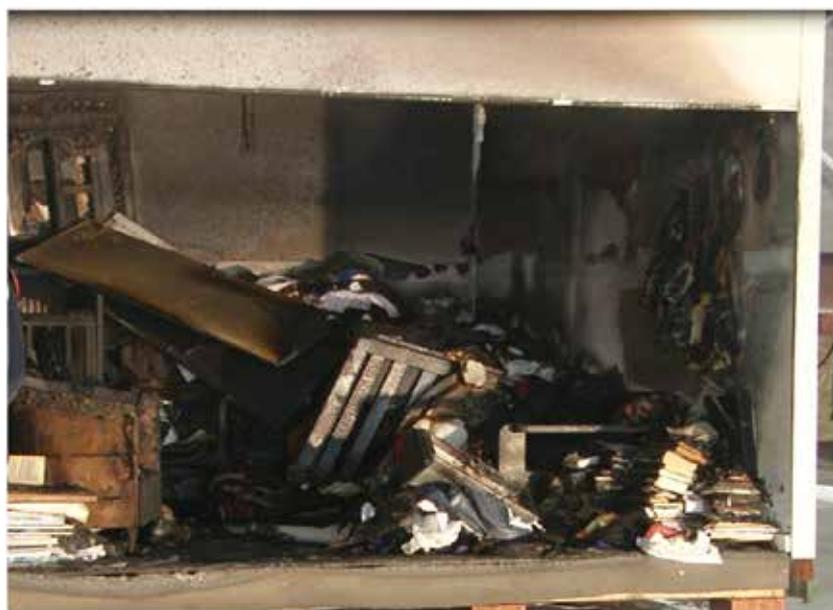
The fire was extinguished quickly with immediate impact. The Thermal Imaging Camera was again used to locate 'hot spots' during overhaul, however as extinguishment occurred soon after flashover the depth of fire penetration into the piled materials was less than for test 1.

Figure 15: Post fire damage and debris (Test 2)

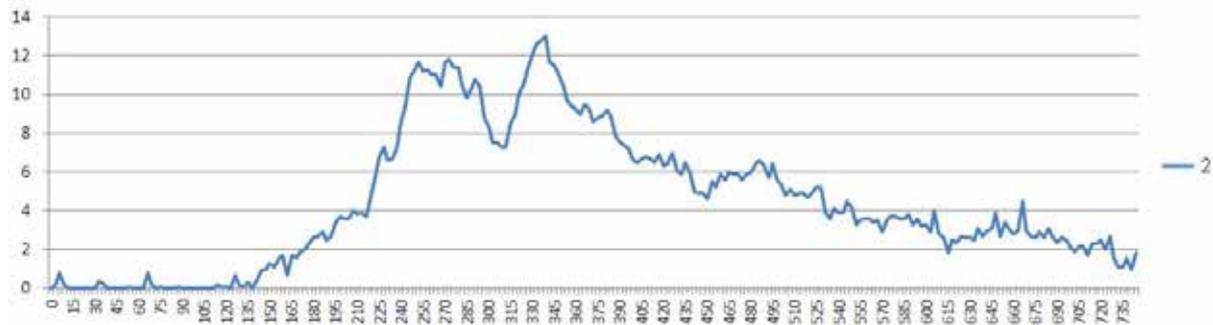
Readings captured from the gas monitors for test 2 were not synchronous indicating that they were possibly not calibrated with the datalogger. Only one of the monitors in test 2 detected elevated CO levels, being no 2 in front of the burn room at ground level. The CO level did not exceed 13ppm in test 2 which is well below the alarm level of 30ppm.

Figure 17: CO level reading from no. 2 multi-gas monitor used in test 2

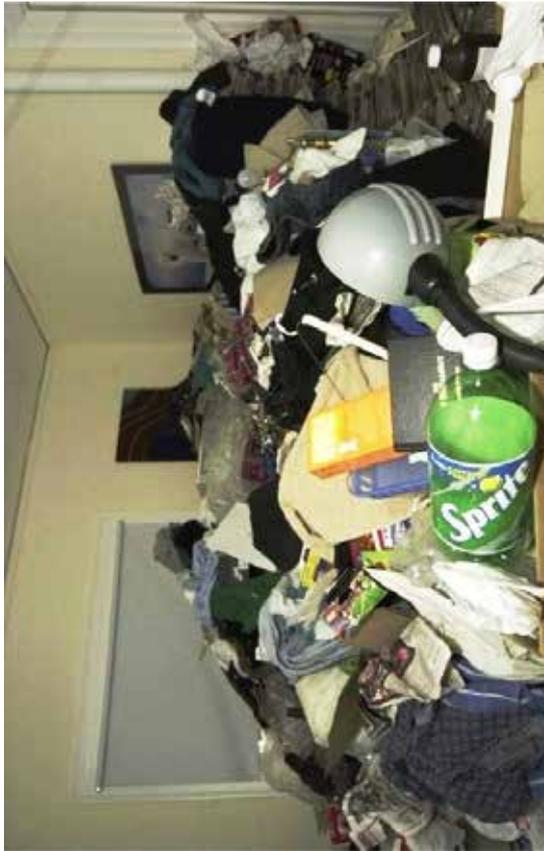
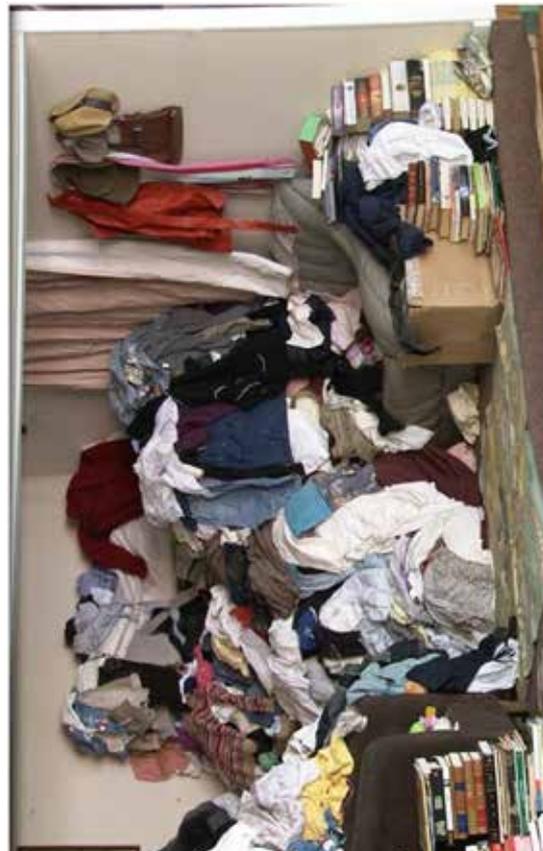
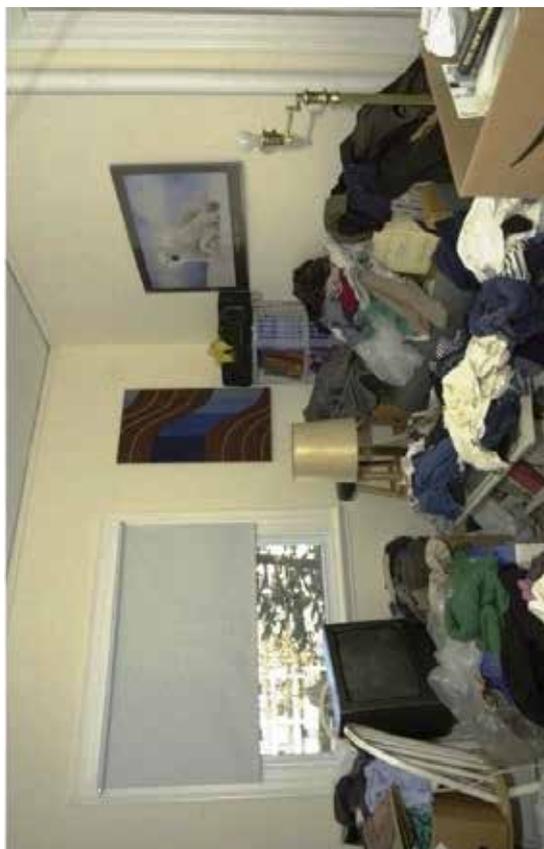
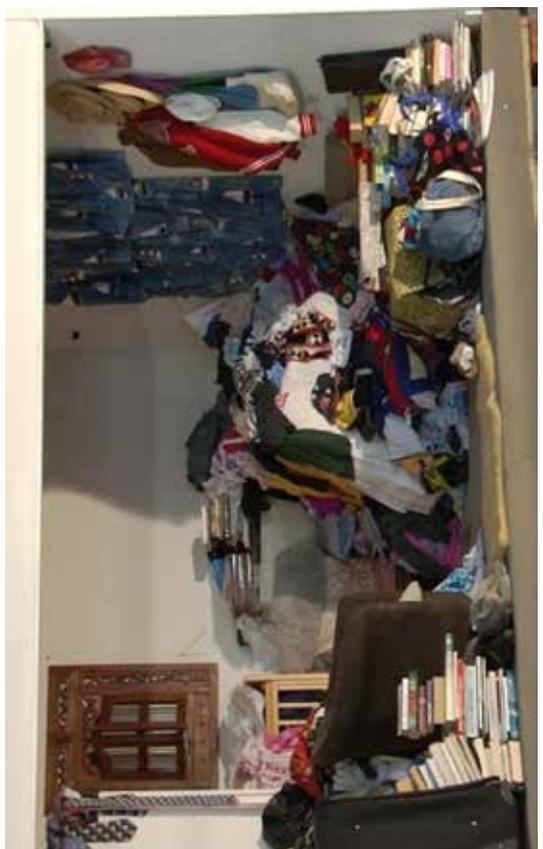
Figure 22: Comparison between example CIR levels and actual CIR levels used in tests

Example of CIR level 8 fuel loading and arrangement

Pre-fire fuel loading and arrangement of Test 1 (CIR 8)

Example of CIR level 5 fuel loading and arrangement

Pre-fire fuel loading and arrangement of test 2 (CIR 5)
